Contract #: 04-0120F4Cty: SF/ALA Rte: 80 PM: 13.2/13.9File #: 69.28**WELDING INSPECTION REPORT****Resident Engineer:**Pursell, Gary**Address:** 333 Burma Road**City:** Oakland, CA 94607**Report No:** WIR-014242**Date Inspected:** 16-Apr-2010**Project Name:** SAS Superstructure**OSM Arrival Time:** 700**Prime Contractor:** American Bridge/Fluor Enterprises, a JV**OSM Departure Time:** 1900**Contractor:** Zhenhua Port Machinery Company, Ltd (ZPMC), Changxing Island **Location:** Shanghai, China**CWI Name:** Mr.Tian Lei**CWI Present:** Yes No**Inspected CWI report:** Yes No N/A**Rod Oven in Use:** Yes No N/A**Electrode to specification:** Yes No N/A**Weld Procedures Followed:** Yes No N/A**Qualified Welders:** Yes No N/A**Verified Joint Fit-up:** Yes No N/A**Approved Drawings:** Yes No N/A**Approved WPS:** Yes No N/A**Delayed / Cancelled:** Yes No N/A**Bridge No:** 34-0006**Component:** Orthotropic Box Girder(OBG)**Summary of Items Observed:**

This CALTRANS OSM Quality Assurance Inspector (QA) Surendra Prabhu was present during the times noted above for observations relative to the fabrication of the Self Anchored Suspension (SAS) Superstructure being performed by Zhenhua Port Machin

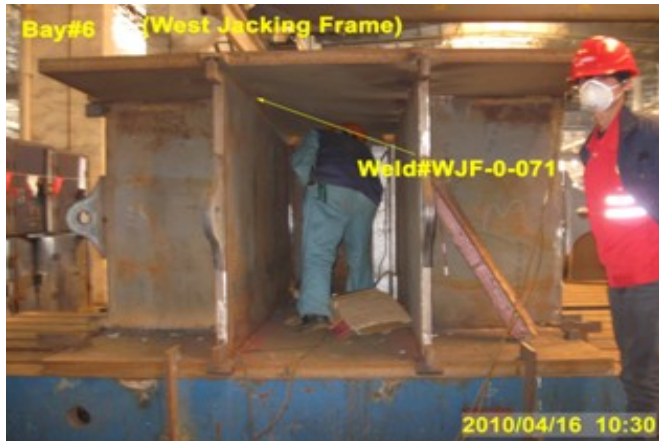
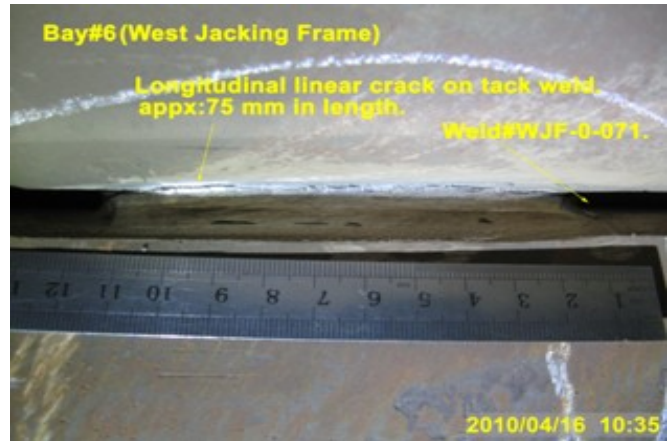
During Quality Assurance Random in process Visual Inspection (VT) review of welds located on Orthotropic Box Girder (OBG) West Jacking Frame WJF-0- 071, this Quality Assurance Inspector (QA) discovered the following issue:

- One (1) Longitudinal Linear Crack observed on the tack weld measuring approximately 75 mm in length.
- The weld is identified as: WJF-0-071.
- According to ZPMC QC they will remove the tack weld and perform Magnetic Particle Testing (MT) prior to welding.
- The attached photographs provide additional detail.

AWS D1.5 2002 figure 6.8 – specifies for fillet weld sizes between 6mm and 13mm the maximum discontinuity length is approximately 2mm to 4mm.

AWS D1.5 (02) Section 6.26.2 – “Welds that are subject to MT in addition to visual inspection shall have no cracks”.

This QA notified ZPMC QC identified as Mr. Zhao Jian Hang and AB/F QA Inspector identified as Mr. Luo Lai Quan of the above issue, and reported to the Team leader.
